COMMUNITY FACILITY ADVISORY COMMITTEE (FAC)
COLUMBUS SCHOOL DISTRICT
COLUMBUS, WISCONSIN

3 COLUMBUS HIGH SCHOOL

COLUMBUS HIGH SCHOOL: EXTERIOR DOOR ANALYSIS

COLUMBUS HIGH SCHOOL: WINDOW ANALYSIS

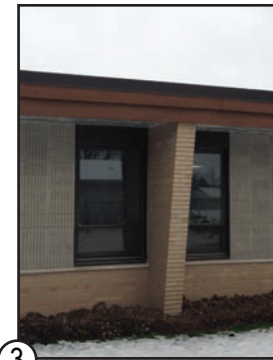
③ ALUMINUM W/ DOUBLE PANE

High School		
No.	Window Type	Consider Replacement
1	Aluminum w/ Double Pane	
2	Aluminum w/ Double Pane	
3	Aluminum w/ Double Pane	Poor window seal and locks
4	Aluminum w/ Double Pane	
5	Aluminum w/ Double Pane	
6	Aluminum w/ Double Pane	
7	Aluminum w/ Double Pane	
8	Aluminum w/ Double Pane
