## MEETING AGENDA

May 6, 2019

# 2 COLUMBUS INTERMEDIATE/ MIDDLE SCHOOL

COMMUNITY FACILITY ADVISORY COMMITTEE (FAC)  
COLUMBUS SCHOOL DISTRICT  
COLUMBUS, WISCONSIN

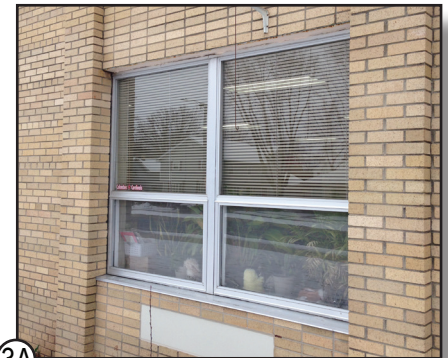
3A ALUMINUM W/ SINGLE PANE

Intermediate/ Middle School		
No.	Window Type	Consider Replacement
1A	Aluminum w/ Double Pane	
1B	Aluminum w/ Double Pane	
2A	Aluminum w/ Single Pane	Replace Single Pane w/ Double Pane
2B	Aluminum w/ Single Pane	Replace Single Pane w/ Double Pane
3A	Aluminum w/ Single Pane	Replace Single Pane w/ Double Pane
3B	Aluminum w/ Single Pane	Replace Single Pane w/ Double Pane
4A	Aluminum w/ Single Pane	Replace Single Pane w/ Double Pane
4B	Aluminum w/ Single Pane	Replace Single Pane w/ Double Pane
5A	Aluminum w/ Double Pane	
6A	Aluminum w/ Double Pane	
7A	Aluminum w/ Double Pane	
7B	Aluminum w/ Double Pane	
8B	Aluminum w/ Single Pane	Replace Single Pane w/ Double Pane
