## MEETING AGENDA

May 6, 2019

# 2 COLUMBUS INTERMEDIATE/ MIDDLE SCHOOL

COMMUNITY FACILITY ADVISORY COMMITTEE (FAC)  
COLUMBUS SCHOOL DISTRICT  
COLUMBUS, WISCONSIN

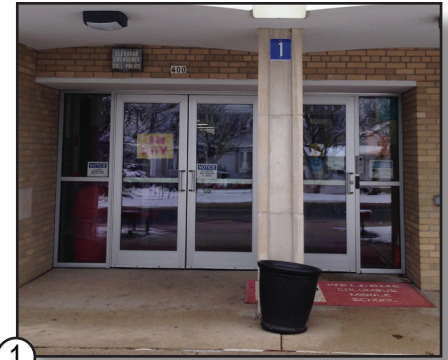
1 ALUMINUM DOORS & ALUMINUM STOREFRONT

Intermediate/ Middle School			
No.	Door Type	Frame Type	Visual Condition
1	Aluminum	Aluminum Storefront	Good
2	Aluminum	Aluminum Storefront	Good
3	Aluminum	Aluminum	Good
4	Hollow Metal	Hollow Metal	Fair
5	Overhead Door - Wood	NA	Fair
6	Hollow Metal	Hollow Metal	Good
7	Hollow Metal	Hollow Metal	Good
8	Hollow Metal	Hollow Metal	Fair
9	Hollow Metal	Hollow Metal	Poor
10	Aluminum	Aluminum Storefront	Good
11	Hollow Metal	Hollow Metal	Good
12	Aluminum	Aluminum	Good
13	Aluminum	Aluminum	Good
14	Hollow Metal	Hollow Metal	Fair

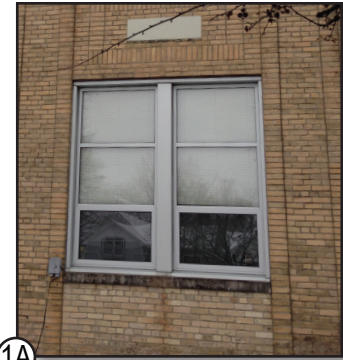
1A ALUMINUM W/ DOUBLE PANE

Intermediate/ Middle School		
No.	Window Type	Consider Replacement
1A	Aluminum w/ Double Pane	
1B	Aluminum w/ Double Pane	
2A	Aluminum w/ Single Pane	Replace Single Pane w/ Double Pane
2B	Aluminum w/ Single Pane	Replace Single Pane w/ Double Pane
3A	Aluminum w/ Single Pane	Replace Single Pane w/ Double Pane
3B	Aluminum w/ Single Pane	Replace Single Pane w/ Double Pane
4A	Aluminum w/ Single Pane	Replace Single Pane w/ Double Pane
4B	Aluminum w/ Single Pane	Replace Single Pane w/ Double Pane
5A	Aluminum w/ Double Pane	
6A	Aluminum w/ Double Pane	
7A	Aluminum w/ Double Pane	
7B	Aluminum w/ Double Pane	
8B	Aluminum w/ Single Pane	Replace Single Pane w/ Double Pane
